Your Inspection Report

148 Dream Home Street
Guelph, ON N1G4B2

Thursday, December 12, 2013

RE: Report No. 1006, v.10
148 Dream Home Street
Guelph, ON
N1G4B2

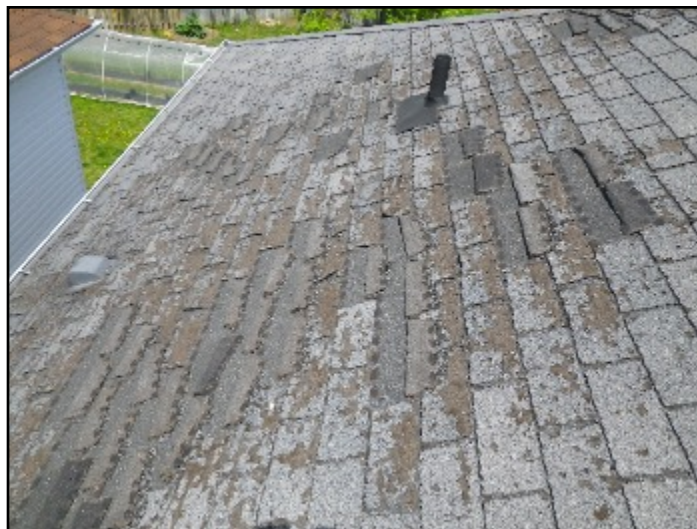
1. Condition: • [Old, worn out](#)

The asphalt shingles are worn out and should be replaced immediately.

Implication(s): Chance of water damage to contents, finishes and/or structure

Task: Replace

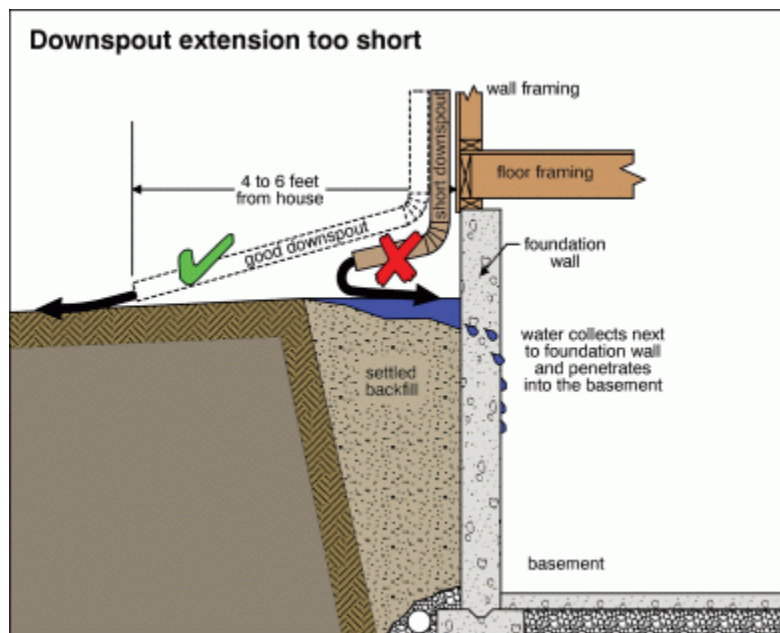
2. Condition: • [Downspouts end too close to building](#)

Downspout discharging too close to building. Extend 4 to 6 feet from foundation to mitigate the chances of water infiltration into the basement.

Task: Correct

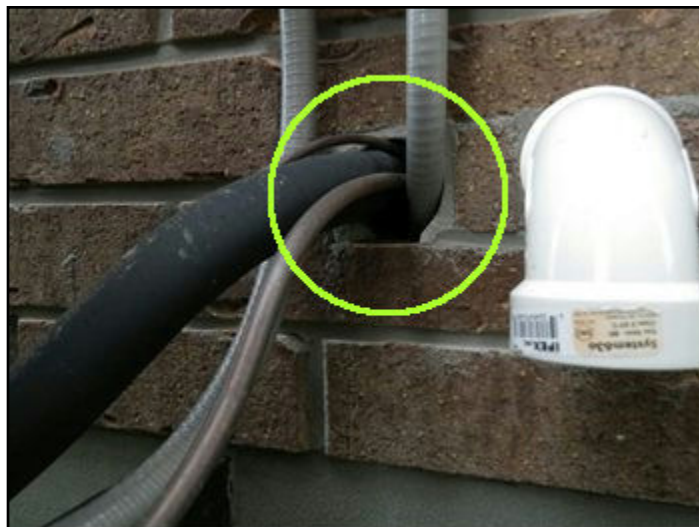
3. Condition: • [Caulking missing or ineffective](#)

Exterior wall penetrations for air conditioner refrigerant lines need to be caulked to reduce the likelihood of moisture infiltration.

Task: Repair

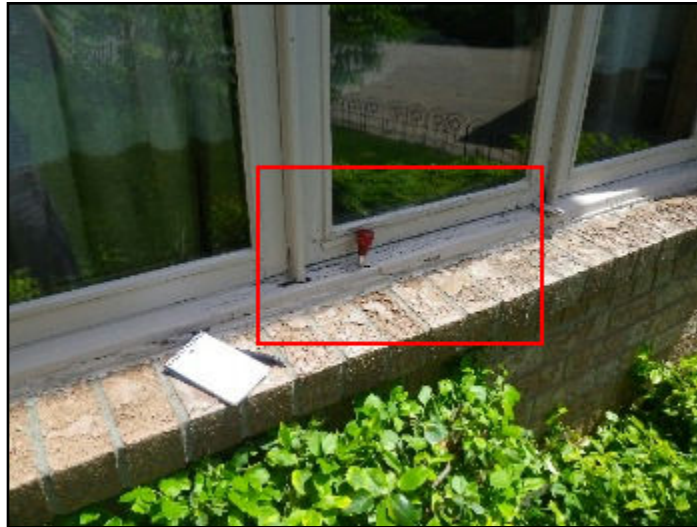
4. Condition: • [Rot](#)

The front right window trim is significantly rotted.

Task: Repair

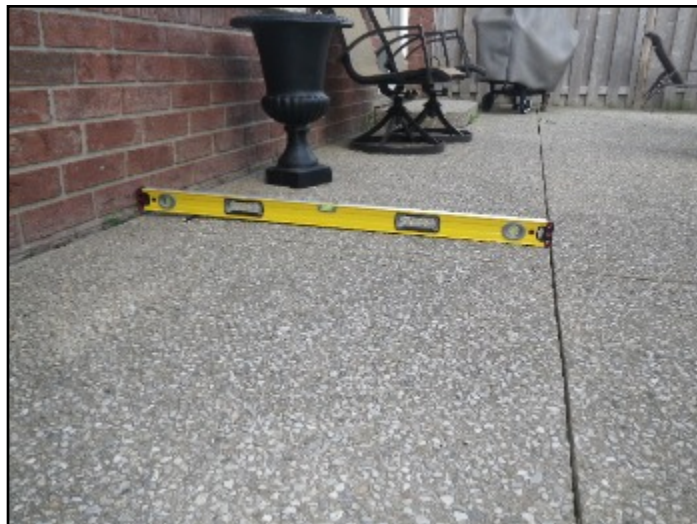
Rear patio slopes towards the building. Correct to move water away from house.

5. Condition: • [Slope toward building](#)

Task: Repair

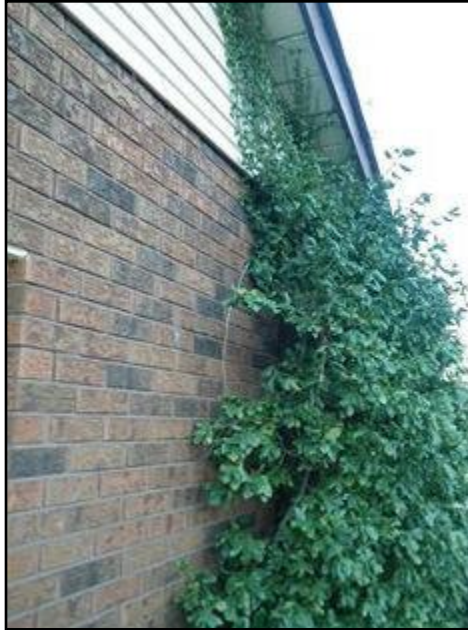
6. Condition: • [Vines](#)

Vines growing on east side of home can damage finishes and shorten the life of exterior wall cladding.

Task: Remove

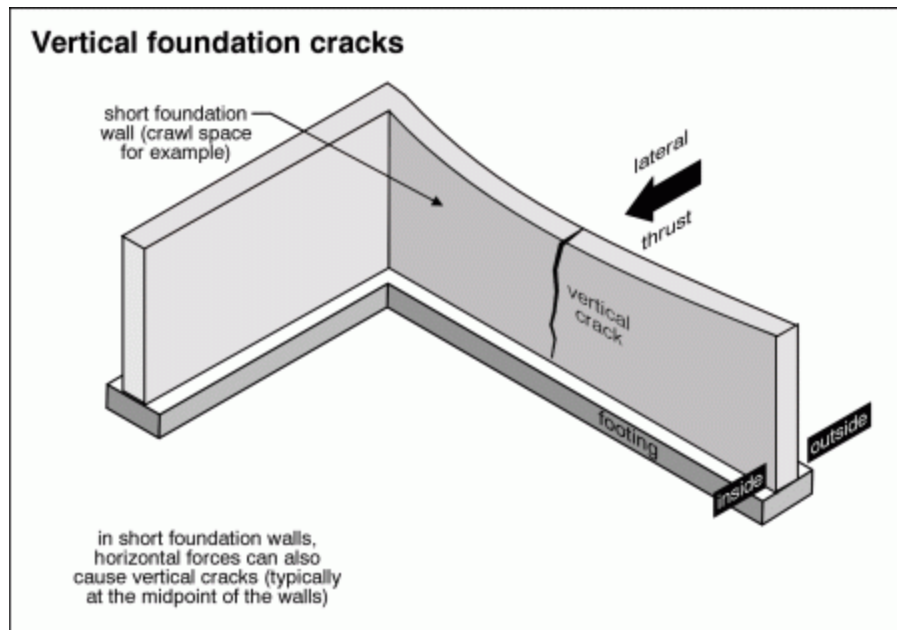
7. Condition: • [Cracked](#)

Typical foundation cracks were noted throughout the foundation. At the time of the inspection we were unable to determine the specific cause of the cracking or if additional cracking will occur. Based on the conditioned observed we recommend closely monitoring the cracks for water infiltration or movement and having a qualified contractor repair them if detected.

Task: Monitor & repair if necessary

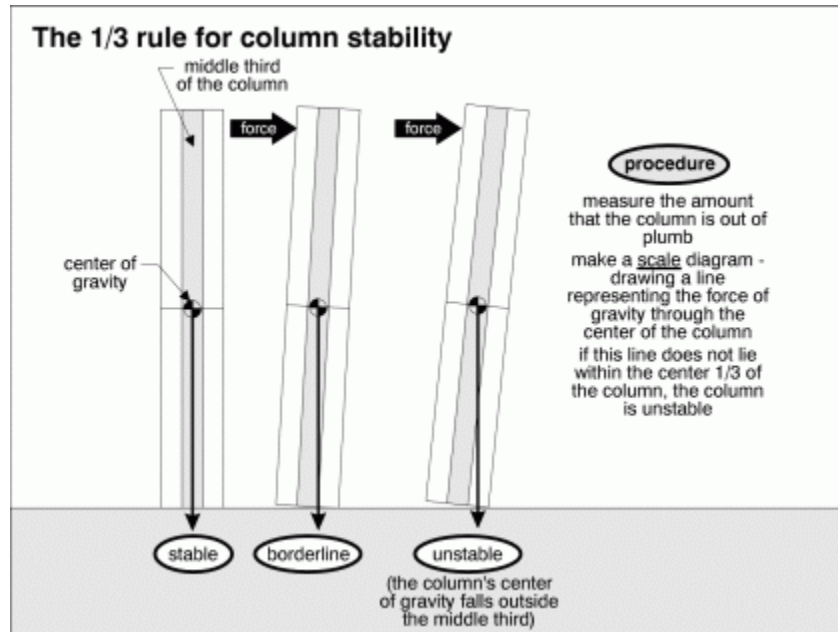
Steel structural column in the basement is leaning outside acceptable tolerances.

8. Condition: • [Leaning](#)

Task: Repair

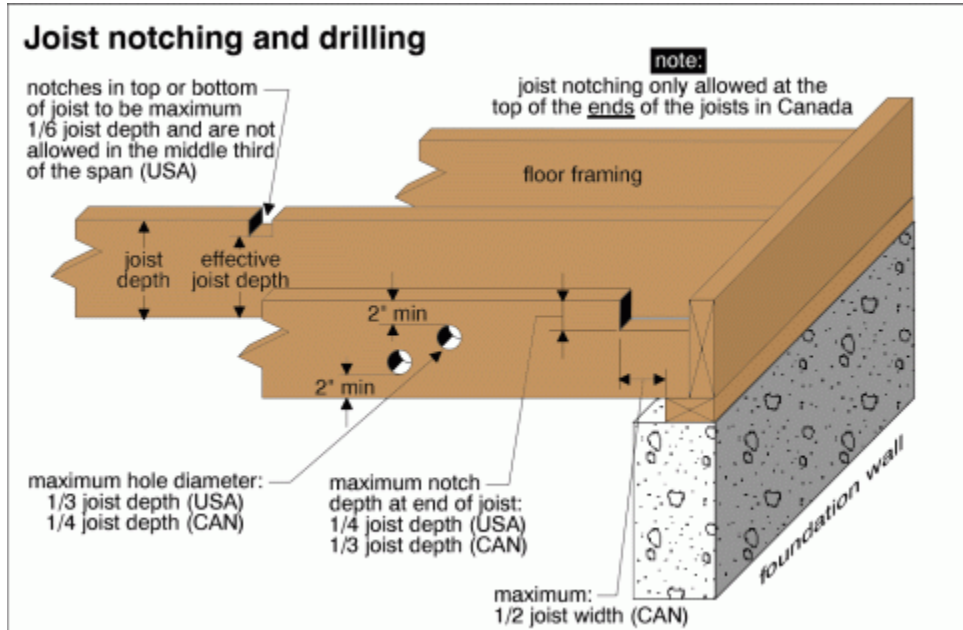
Floor joist cut to provide space for plumbing in mechanical room.

9. Condition: • [Notches or holes](#)

Task: Repair

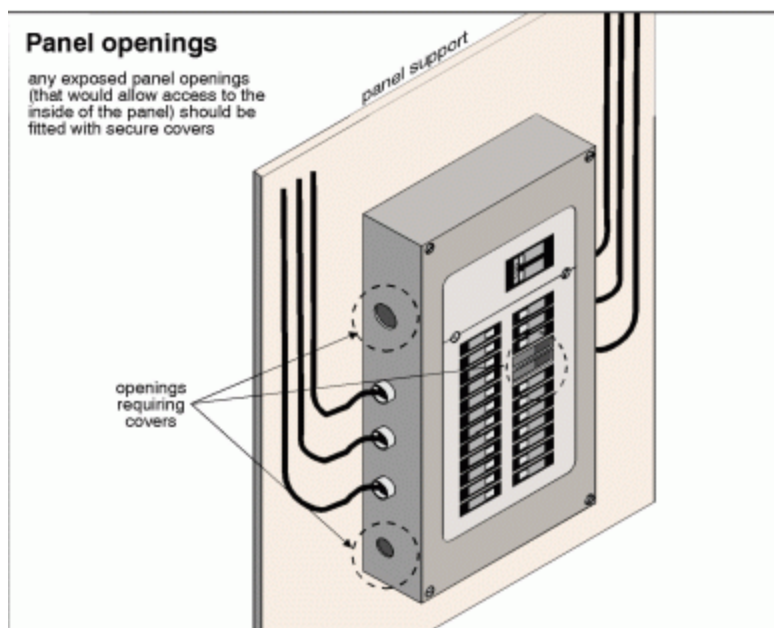
10. Condition: • [Openings in panel](#)

Implication(s): Electric shock | Fire hazard

Task: Correct

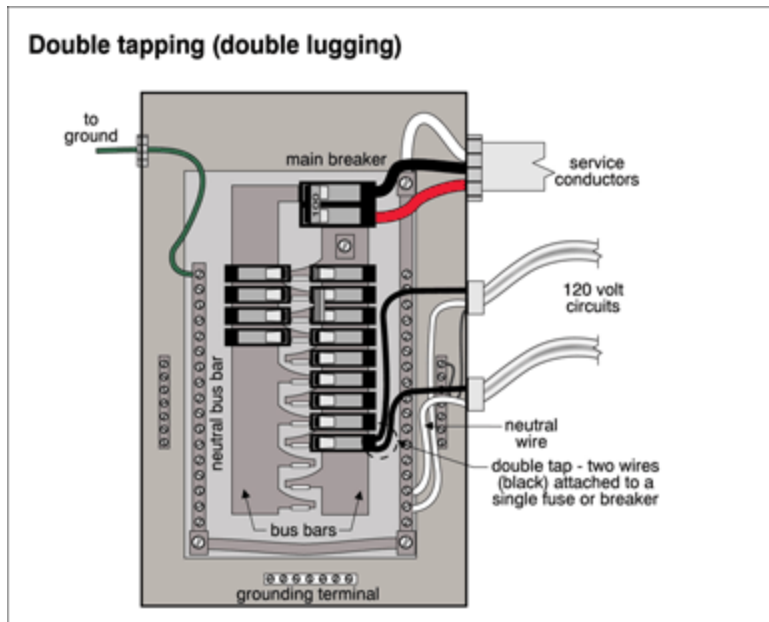
11. Condition: • [Double taps](#)

In the electrical distribution panel, two wires are attached to a single breaker. Most terminals are not designed to accommodate two wires. The risk of a poor connection is greater with double taps.

Task: Repair

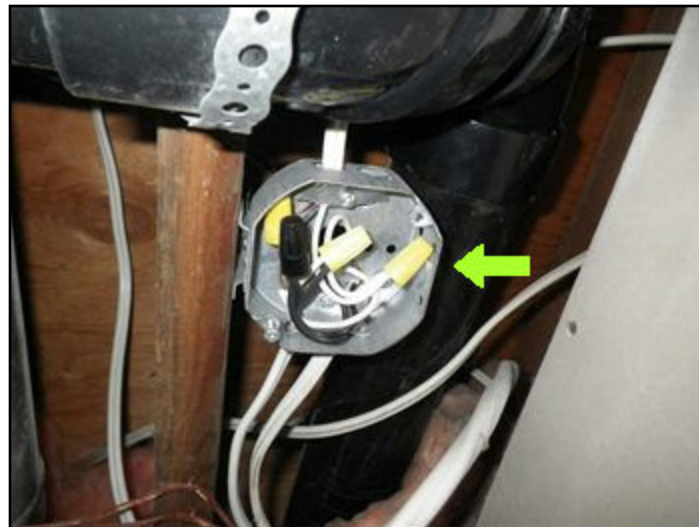
12. Condition: • [Cover loose or missing](#)

Cover plate missing off electrical junction box in utility room.

Task: Provide

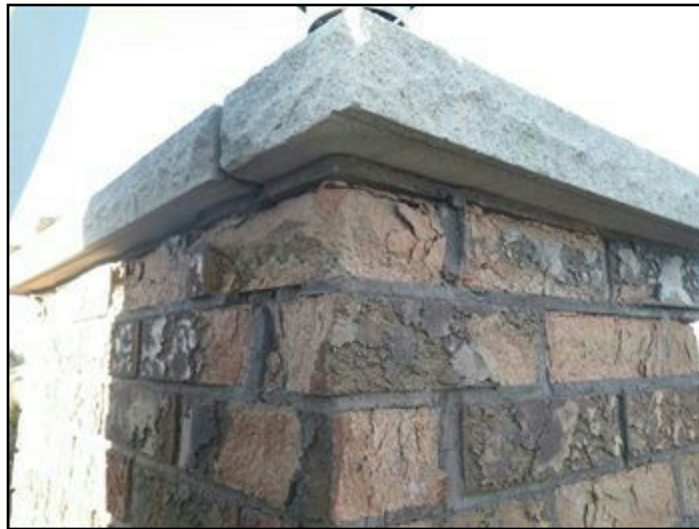
14. Condition: • [Spalling](#)

The masonry chimney is spalling.

Task: Repair

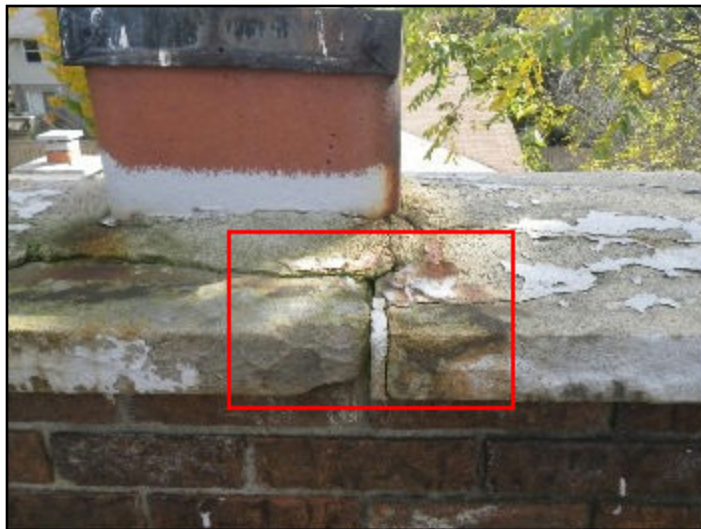
15. Condition: • [Spalling](#)

The chimney cap is spalling and mortar deteriorated.

Task: Repair

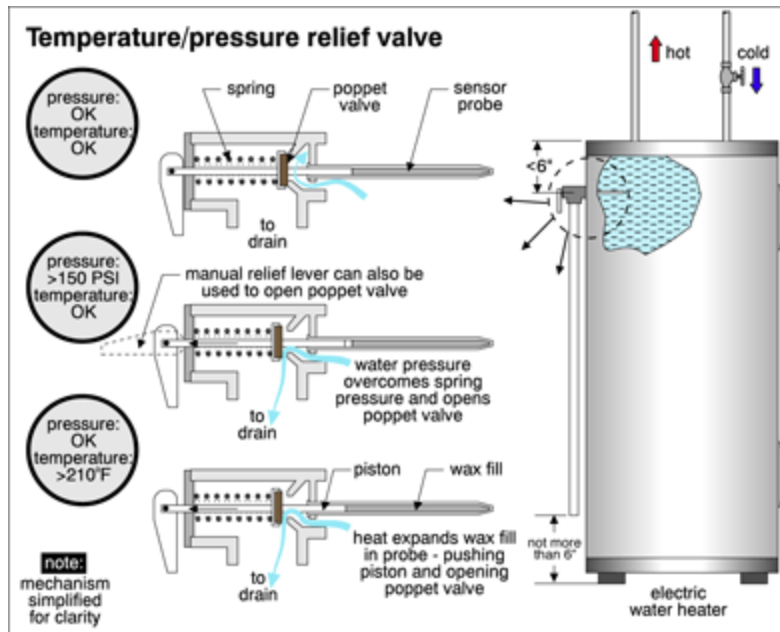
21. Condition: • [Discharge tube missing](#)

Discharge tube for pressure release valve missing from hot water heater.

Task: Repair

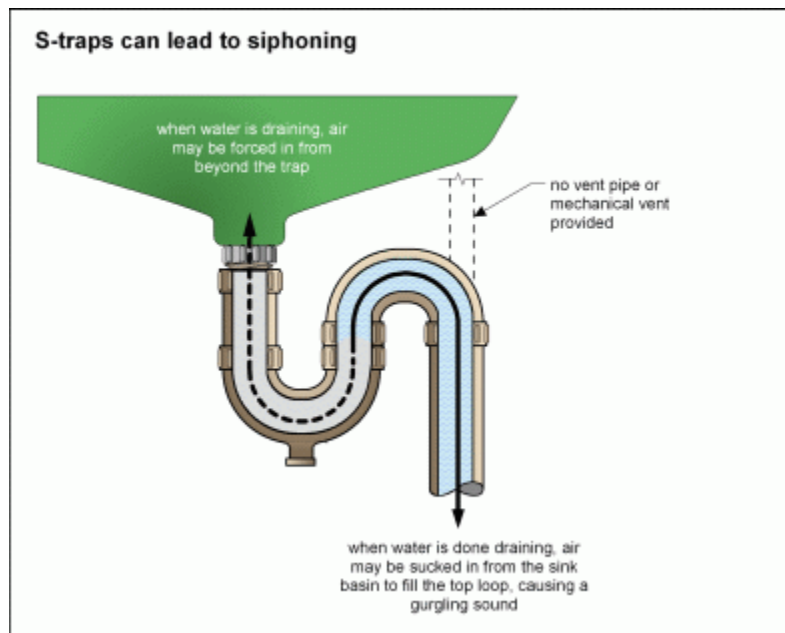
Waste plumbing for laundry basin has an S-trap. The implication of an S-trap is siphoning of the water in the trap and possible sewer gases entering the living environment.

22. Condition: • [Wrong type](#)

Task: Repair

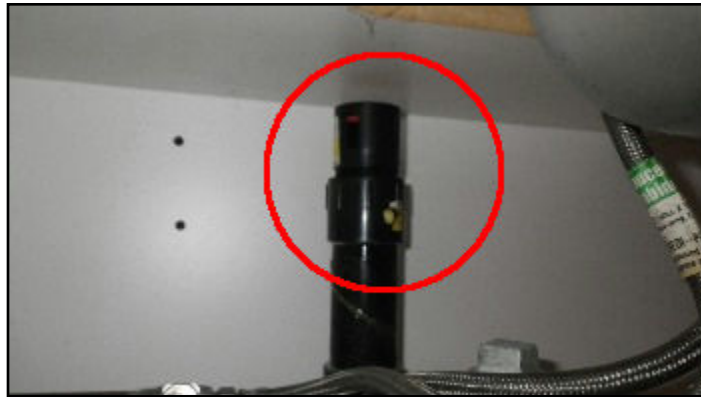
23. Condition: • [Automatic air vents](#)

Improper automatic vents installed in waste plumbing system under kitchen sink.

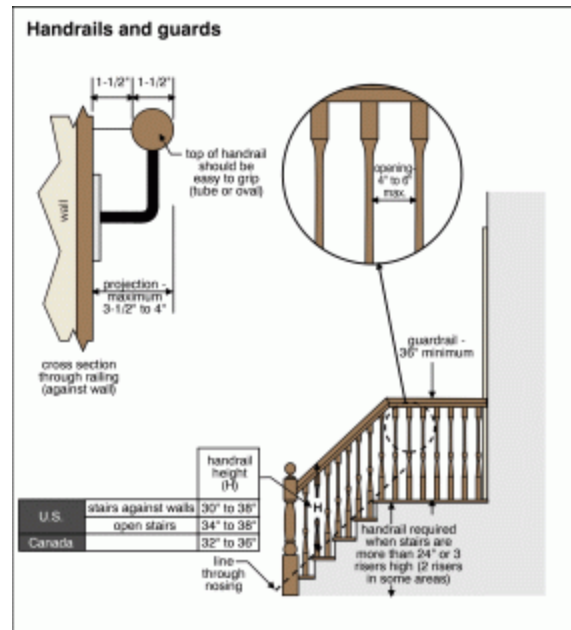
Stairs from garage to mudroom have no handrail.

26. Condition: • [Missing](#)

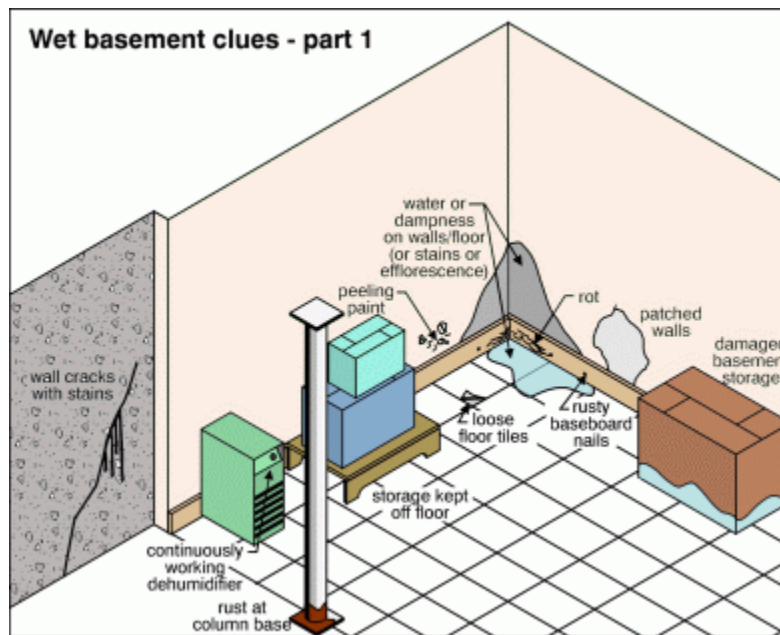
28. Condition: • [Dampness on floor or walls](#)

Elevated levels of moisture detected in the rear basement wall. Further evaluation required by a qualified contractor to confirm the moisture and provide a repair solution.

Task: Further evaluation and repair
